Installation of Self-Closing Flood Barriers and Loading Dock Turntable Removal and Structural Slab Repairs

Outstanding Repair Project Award

1. Project Name: National Archives and Record Administration
Installation of Self-Closing Flood Barriers and
Loading Dock Turntable Removal and Structural
Slab Repairs.
2. Location: Washington, DC
3. Contract Amount: \$931,480.00
4. Project Duration: May 15, 2008 – March, 2009

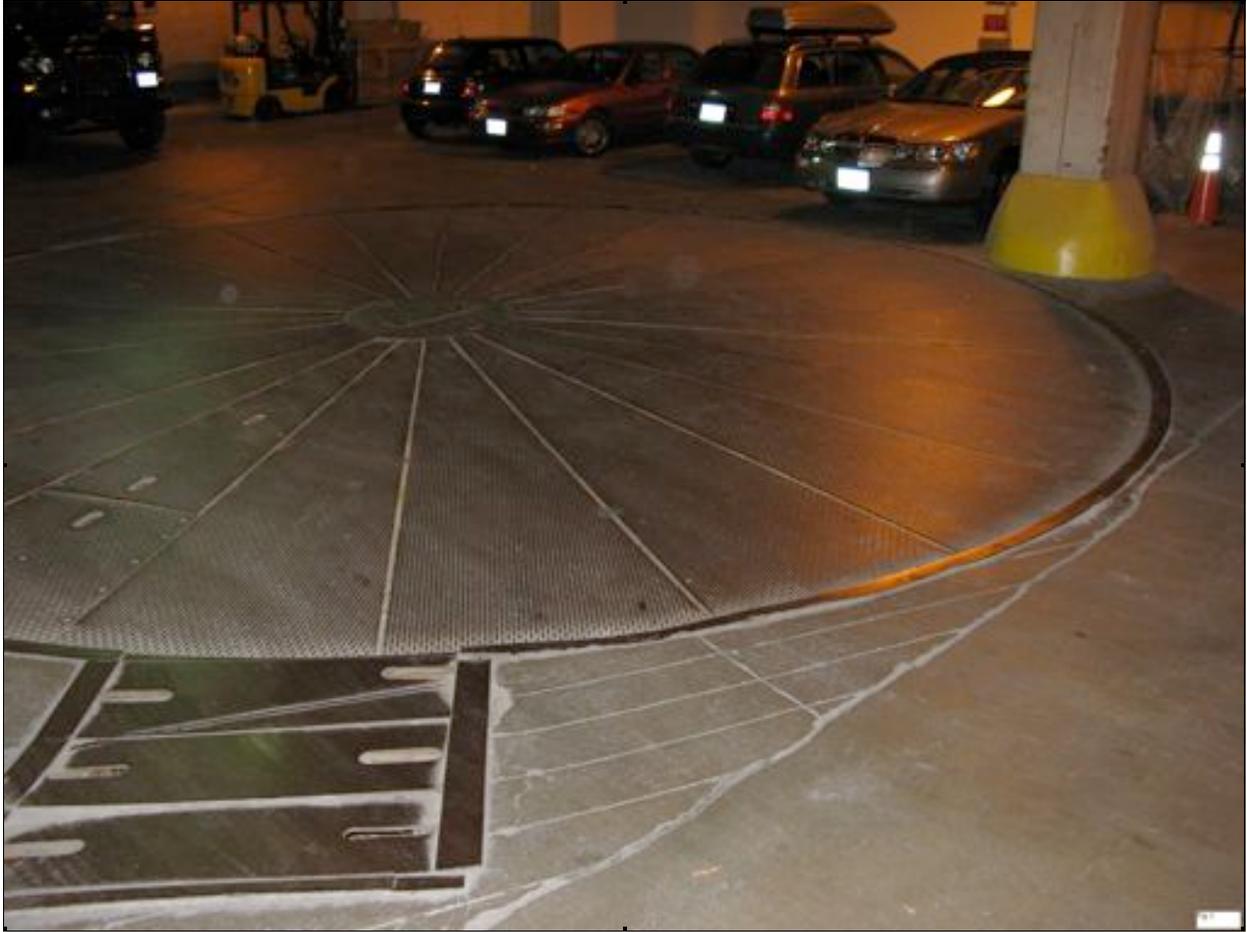
Prior to the installation of the flood gates, it was determined that the loading dock turntable (Fig.3), would need to be removed. The Turntable inside the loading dock was used to maneuver trucks delivering materials and supplies to the building, and was utilized to assist in positioning van pool vehicles and limousines for VIP's in loading dock parking spaces. It had been determined that the turntable was obsolete, needed to be removed, and the removal and associated structural repairs would need to be performed with the planned loading dock closure for the flood gates. Closing the loading dock required arranging for a different delivery site at the building and this necessitated the relocation of a security detail and their x-ray equipment. As this proved to be an untenable arrangement, the NARA project officials requested the work schedule be modified to complete the work in a two week period rather than the planned two month time frame.

The thirty foot diameter steel turntable was removed by cutting it into manageable sections for disposal. Next, the interior area of the turntable, which was four feet deep, was formed and prepared to receive the structural concrete joist slab; the 4000 psi mix was placed and finished to match adjacent surfaces. All work associated with the removal and infill of the turntable was completed in a two week schedule which included weekend shifts.

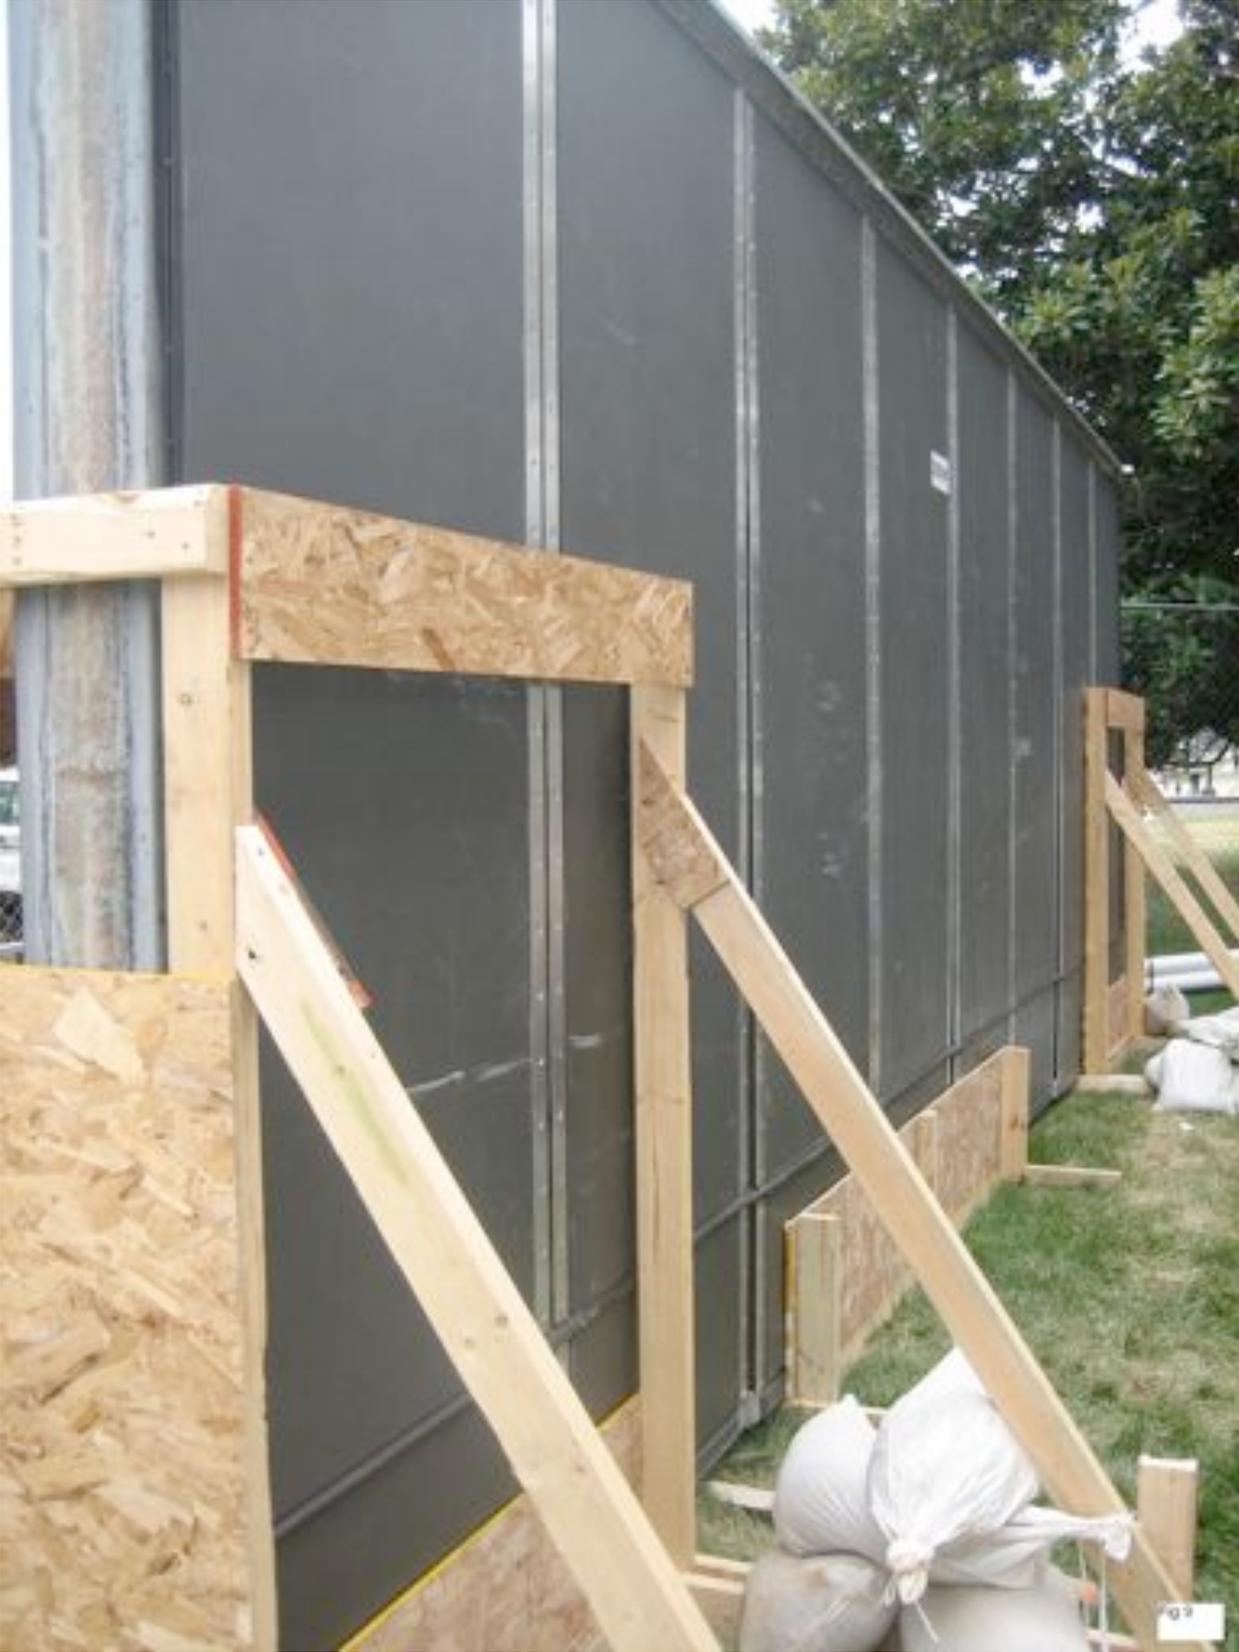
foundation wall required position alteration in order to receive the cap beam form (Fig. 11). Prior to placing concrete in the cap beam forms, the manufacturer's rep from PS Doors inspected the newly placed beam forms to verify the distance between the cap beams was to exact measurements in order to eventually receive the flood barrier gate hardware. Concrete was placed in the cap beams (Fig. 12), and following adequate curing time the flood barrier doors and associated hardware were installed. A flood test was successful and the self-closing flood barriers functioned as designed (Fig. 13).
