Pentagon Renovations— Exterior Wall Repair and Interior Structural Repair

Arlington, Virginia

Submitted by Concrete Protection & Restoration, Inc.

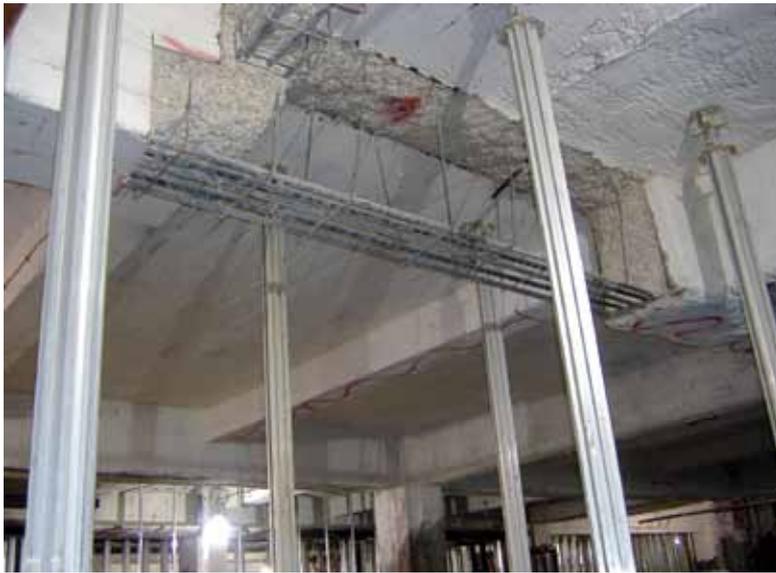
Interior beam repair work—notice the extensive shoring

In one particular area, the removal of the interior finishes uncovered a large section of the second-floor structure that had been damaged by an historical fire. This unexpected repair required full-depth removal of beams and girders, some more than 4 ft (1.2 m) deep. After the floor slab was extensively shored, the damaged concrete was removed, the beams were formed, and ready mixed concrete was placed from the above level.

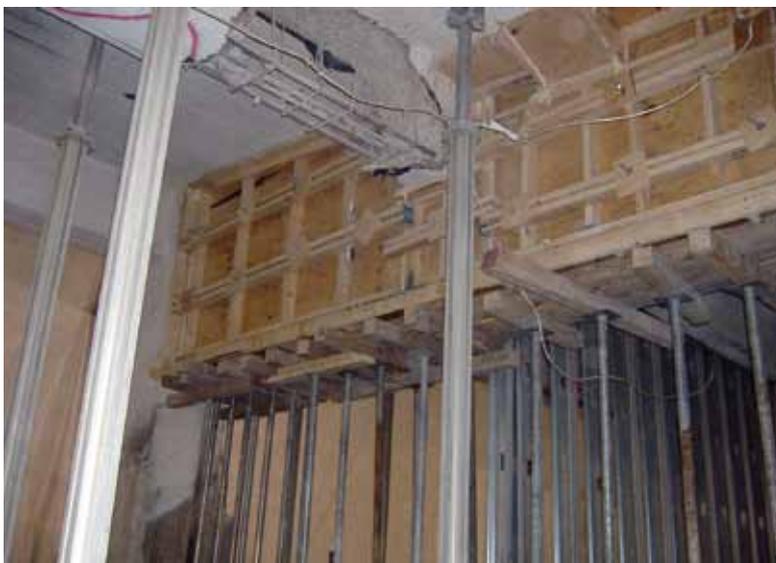
View of the full-depth beam repair

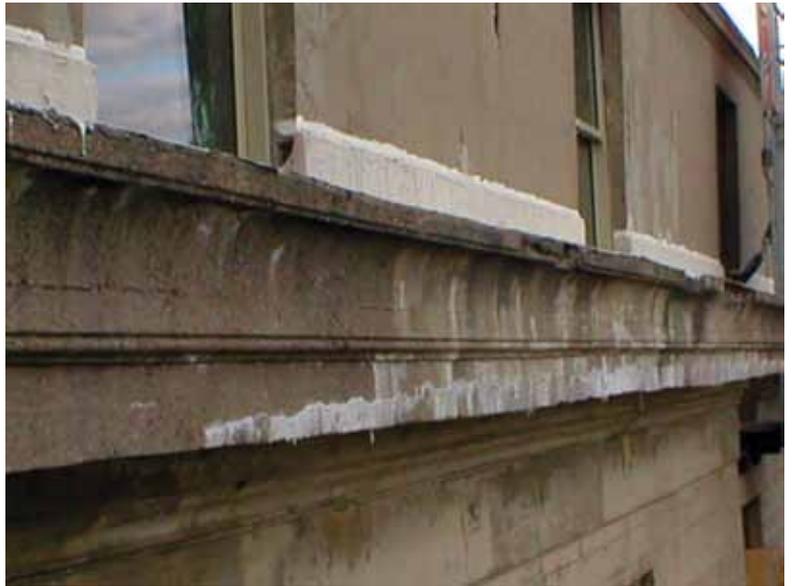
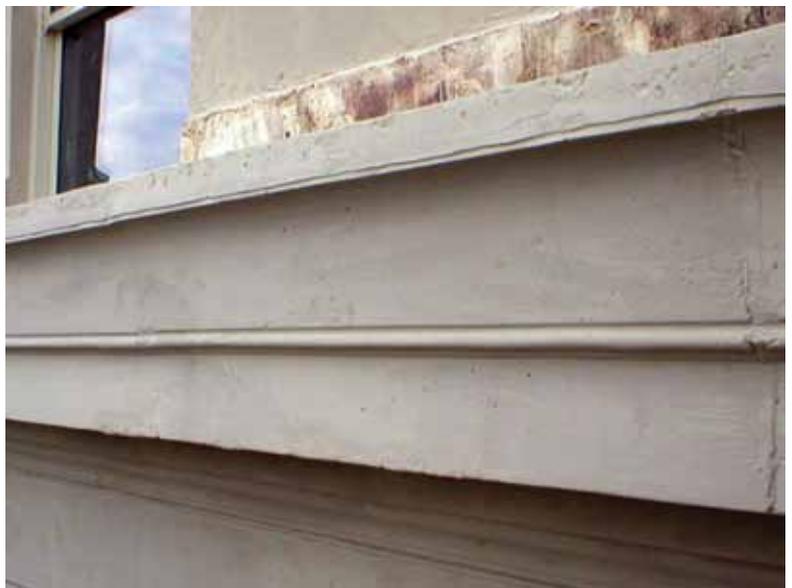
Close-up of repaired area on walls, before and after

To meet the specification requirements that the repairs are not detectable from a distance of 30 ft (9 m), the contractor used rough-cut lumber to match the texture of the original surface. Each board was cut specifically to match the varying widths of the existing wall, and the edges were beveled to create the “ribbed” finish.

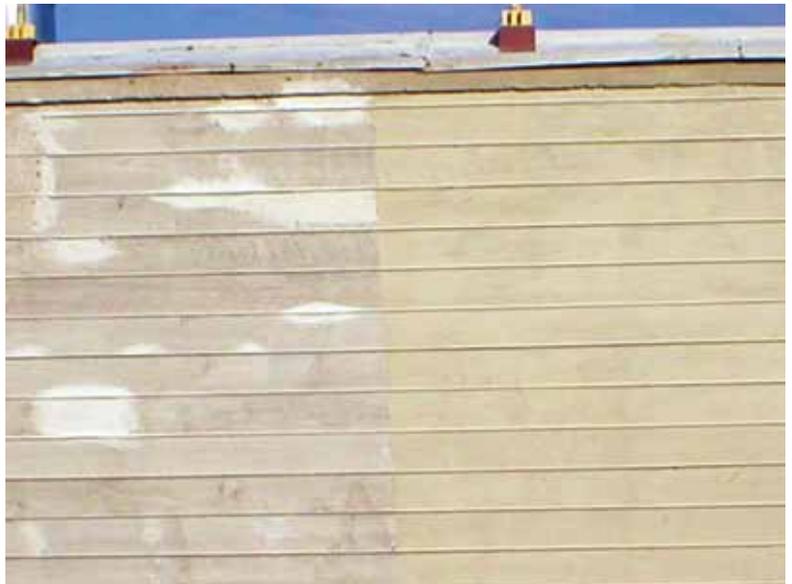
Before and after coating application

- A mineral-based coating was applied to provide a preventative waterproofing for the unrepaired concrete areas, protect the new repairs, act as further prevention against water absorption, and give the building a uniform appearance. This potassium silicate coating was chosen to form a chemical bond with the concrete, yet allow the cast-in-place structure to breathe and be permeable. The coating system chosen is high in pH to protect the reinforcing steel and concrete from carbonation.

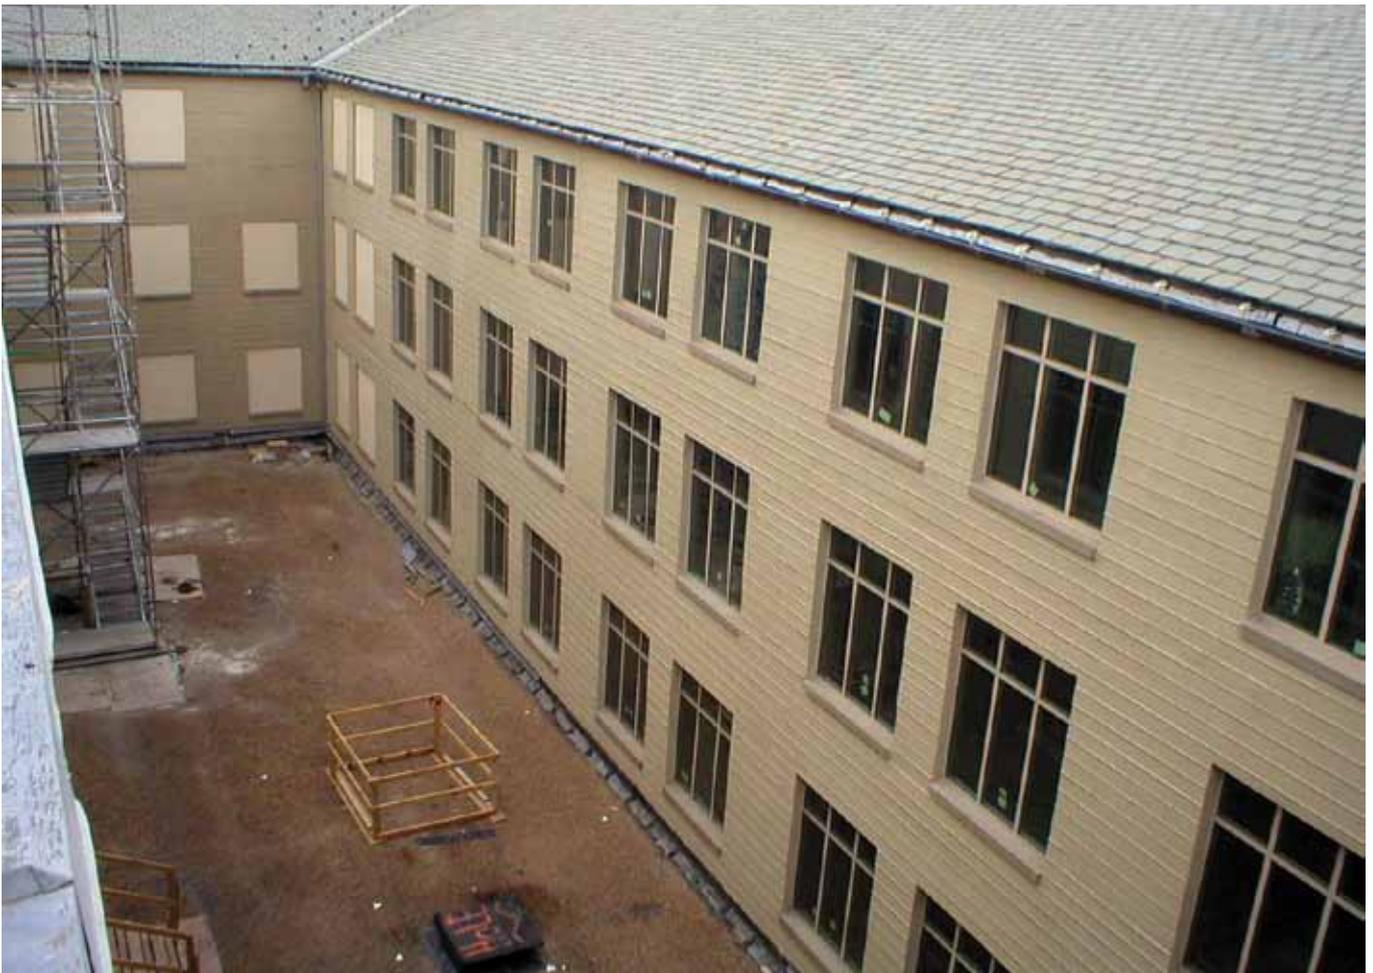
Completed repairs
