Concrete Protection & Restoration 1000 Vermont Facade Repair

1000 Vermont Avenue SPE LLC c/o LPC

Smislova, Kehnemui & Associates, P.A.

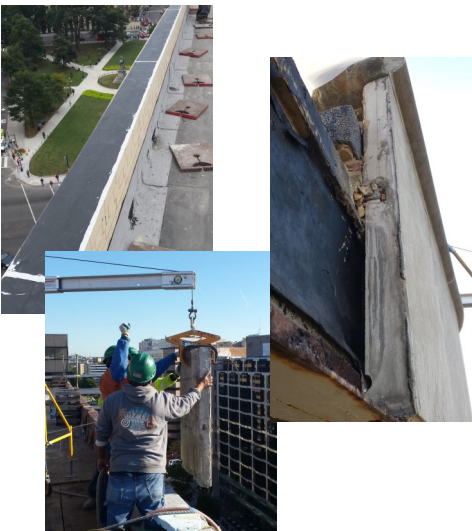
The 1000 Vermont Avenue building is located in one of the busiest intersections in northwest D.C. It was built sometime in the 1960s and it consists of a twelve story structure with continuous window and precast bands. The 11th floor contains a recessed balcony area along the Vermont and K Street elevations. The floors up to the 11th level contain precast panels, approximately 48" tall and 36" wide, which are connected to each floor slab. Nonetheless, the 12th floor and the main roof precast panels are supported by steel lintels and a masonry parapet wall. There is a precast bull-nose coping on top of the exterior vertical precast and masonry parapet wall.

The intention of this project was to repair and waterproof the existing parapet wall, precast, and steel lintels on the 12th floor and roof levels along the K Street and Vermont Avenue elevations. This was an extremely difficult project with limited access and storage. Once removed, the panels needed to be numbered and carefully stored. Removal and reinstallation of the panels was challenging. Clamping mechanism and Lewis pins were used to remove and reinstall the panels. The facade repair project sequence was executed as follows:

- ◇ The entire masonry parapet wall, precast bull-nose, vertical precast on the 11th and 12th floors and roof level were completely removed down to the structural roof slab to disengage the vertical precast. Adequate lateral bracing of the vertical precast were provided during the removal of the masonry parapet wall. All precast elements were salvaged and re-installed.

- ◇ Once the removal of the precast and parapet wall were completed on the 11th and 12th floors, the steel support was removed and replaced with new ones. The interior steel angle exposed surfaces were cleaned via wire wheel, corrosion inhibitor was applied, and these exposed steel surfaces were painted. New flashing were installed on the exterior steel angles after the replacement of the new angle.

- ◇ The steel radius on the 11th and 12th floor were completely removed and a new one had to be fabricated to match the exiting radius conditions.
- ◇ The vertical precast elements were reinstalled after new lateral tie clips were secured into the precast prior to the re-installation.

- ◇ The masonry parapet walls were re-built to match the original as-built construction and two rows of horizontal joint reinforcement were installed between the structural slab and bull-nose as well as new fully grouted vertical reinforcing were installed in the block and epoxied into the slab.

- ◇ New aluminum counter flashings were installed on the exposed masonry face of the parapet wall to prevent any water penetration into the masonry parapet wall.

- ◇ All roofing gravel, insulation, elastofom flashing with bonding adhesive, rubber nailing strip were replaced to tie into the existing ballasted single ply roof membrane over 2" rigid insulation and 1" perlite insulation.

- ◇ The bull-nose was replaced on a mortar bed after all masonry and flashing were installed and cured. All precast-to-precast joints were sealed with polyurethane and weep holes were provided at the bottom of the vertical precast joints within the polyurethane sealant.

- ◇ All sealants were repaired and replaced on all levels of K Street and Vermont Avenue elevations and all steel lintels on the 2nd thru the 11th floors were cleaned and painted.

- ◇ All slab spalls were repaired on the 12th floor.
