FOXHALL SQUARE GARAGE POST-TENSIONED CABLE REPAIR AND REPLACEMENT

BY MICHAEL K. O'MALLEY

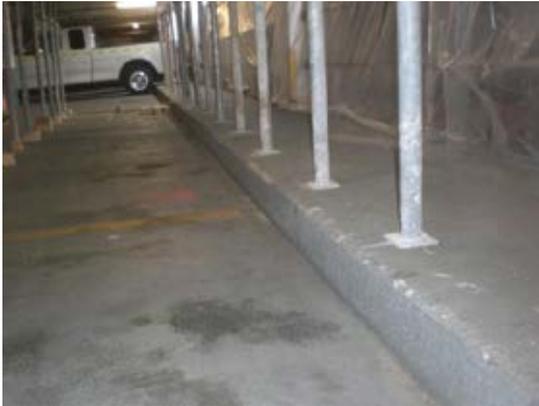
Fig. 1: Temporary shoring and dust control measures

A shoring plan was designed to support the upper level of the garage, and construction fencing and dust barriers were installed (Fig. 1). To maintain the owner's construction schedule, a crew of 20 workers was deployed to the site; they worked 6 days per week, 10 hours per day. Construction personnel were required to work during inclement weather, resulting in the physical challenge of laboring in

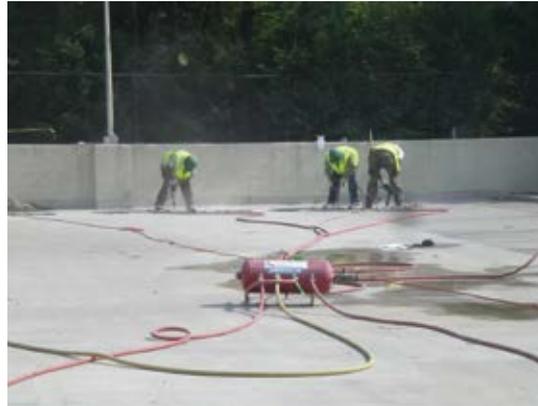
Fig. 2: Workers exposing tendons with small chipping hammers

The concrete demolition proceeded quickly, with openings made throughout the upper deck that exposed previous repairs and anchor locations (Fig. 2 and 3). While certain crews continued on demolition and slab openings, others were busy installing new cables (Fig. 4 and 5). A steady progression was maintained by using remaining personnel to install the intermediate stressing anchorage and splice chuck repair hardware for the upcoming cables that were slated to be stressed (Fig. 6 and 7). As the project moved forward and

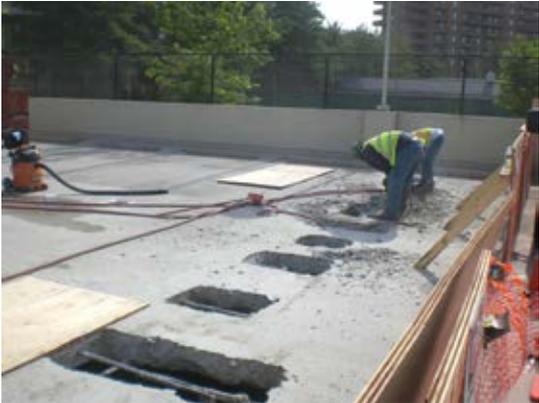
Fig. 3: Exposed anchor locations

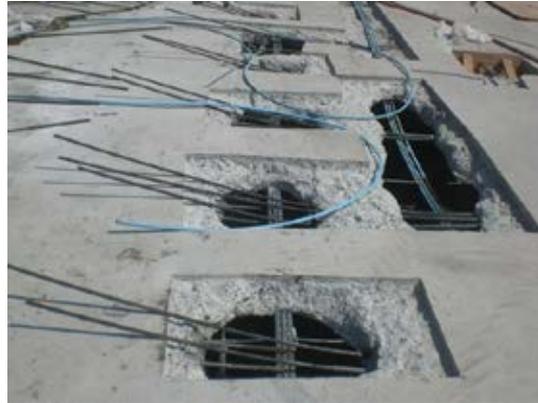
Fig. 4: Newly installed cables

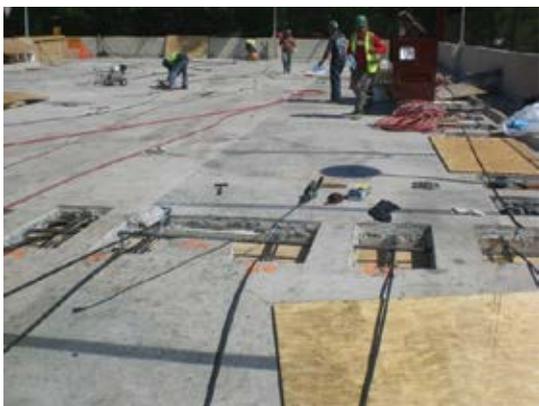
Fig. 5: Simultaneous operations

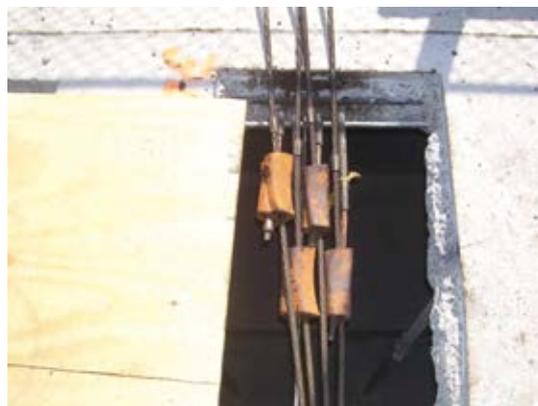
Fig. 6: Spliced cables

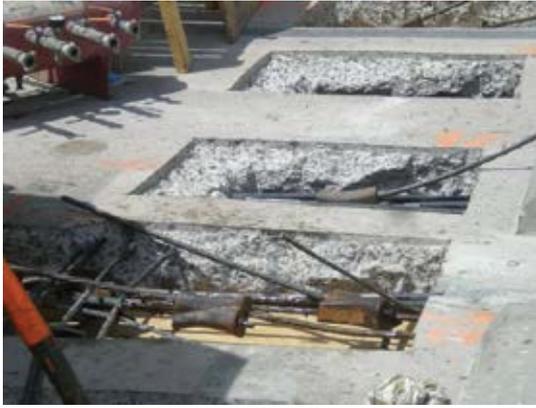
Fig. 7: Spliced cables ready for tensioning

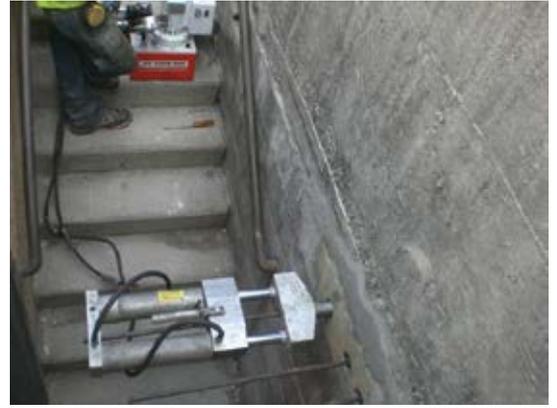
Fig. 8: Tensioning new cables in stairwell

Stressing of the new post-tensioned cables (Fig. 8 and 9) was initially performed as planned; however, the project engineer had to make adjustments to the stressing tension after a few cable tendons ruptured during the tensioning operation. A completed stressing of an intermediate stressing anchorage with the wedges seated is shown in Fig. 10. Following the tensioning operation, concrete was placed in the repair cavities (Fig. 11 and 12). The newly placed concrete was finished to match the surface and texture of the adjacent concrete as closely as possible (Fig. 13).

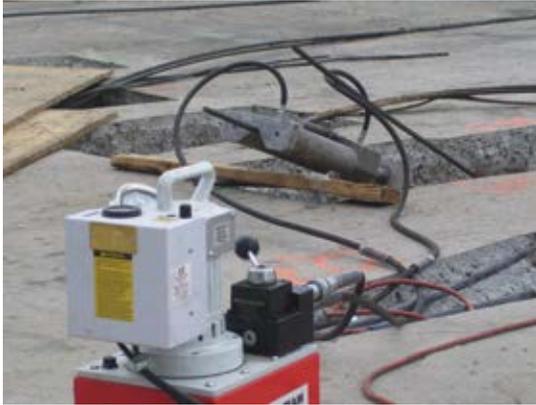
Fig. 9: Tensioning new cables on deck

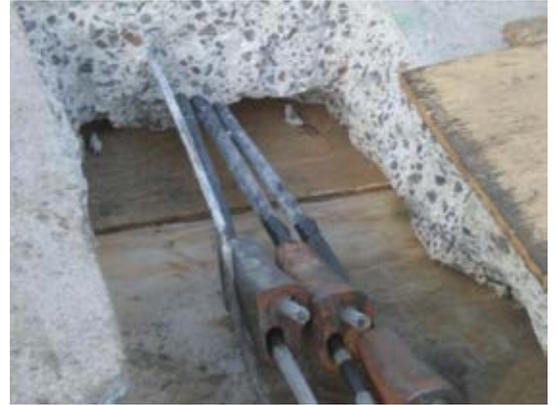
Fig. 10: Newly stressed tendon

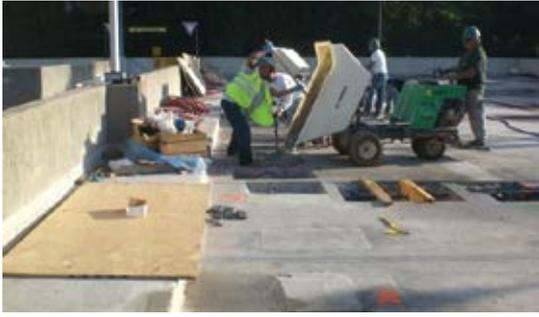
Fig. 11: Pouring concrete repair material

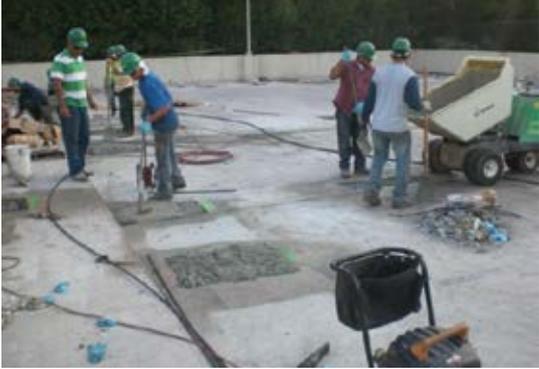
Fig. 12: Consolidating patch material

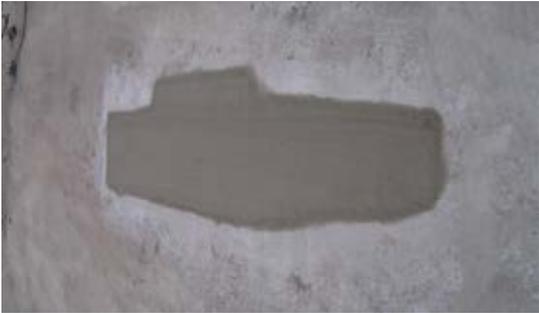
Fig. 13: Final surface of patch repair
