Concrete Protection & Restoration

Singer Island Hilton Hotel

Singer Island, Florida

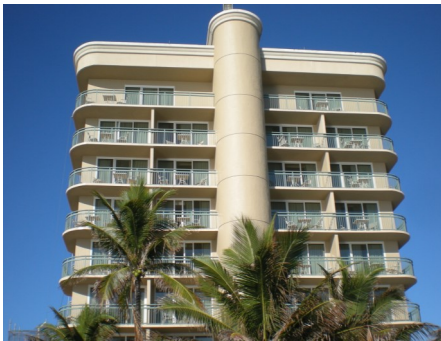
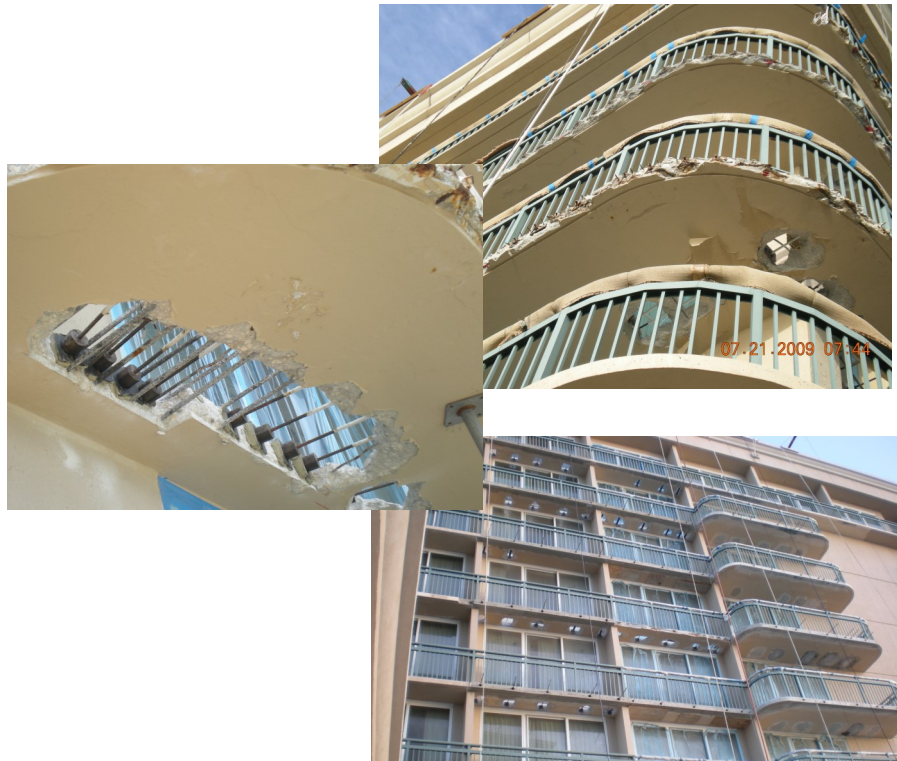
This eight story hotel building is approximately twenty three years old. The building frame consists of post-tension concrete slabs supported by reinforced concrete columns. The main building has rectangular and curved shaped balconies on all four elevations. The balcony slabs are approximately 5 1/2" thick and have embedded aluminum handrail posts near the edges. The top portion of the balcony slabs and balcony slab edges have a urethane coating with aggregate. There was damaged balcony slabs on all elevations, east, north, south, and west elevation tiers.

- ◇ Full depth and partial depth surface concrete repairs
- ◇ Reinforcing steel repair and slab edge repair
- ◇ Post-tension cables and anchors repairs as well as replacement of severely corroded tendons with new 1/2" diameter tendons.
- ◇ Post-tension anchors coating and replacement with new epoxy coated anchors
- ◇ Handrail post repairs and coating of balcony slab surfaces
