Installation of Self-Closing Flood Barriers and Loading Dock Turntable Removal and Structural Slab Repairs

Outstanding Repair Project Award

1. Project Name: National Archives and Record Administration
Installation of Self-Closing Flood Barriers and
Loading Dock Turntable Removal and Structural
Slab Repairs.
2. Location: Washington, DC
3. Contract Amount: \$931,480.00
4. Project Duration: May 15, 2008 – March, 2009

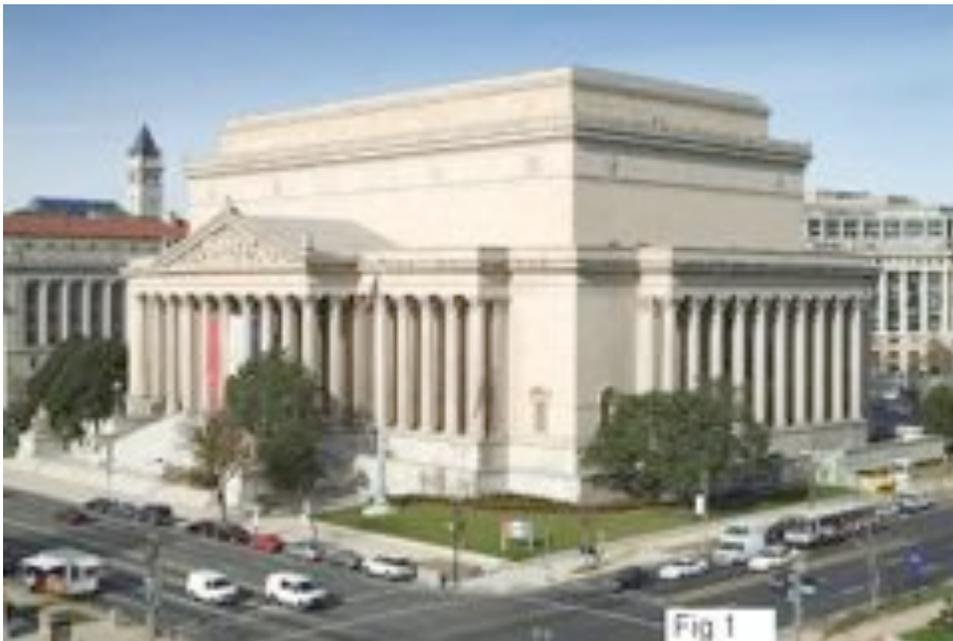
Having experienced severe flooding to the buildings lower levels during severe storms in recent years, resulting in the loss of some important documents, computer equipment, furniture and a lower level theater, a plan was devised to install self-closing flood barriers at both the east and west vehicular entrances to the Archives building. The building is sited between 7th and 9th Streets, NW, with the south facade fronting Constitution Ave., and the north fronting Pennsylvania Ave., NW, in Washington, DC. (Fig. 1)

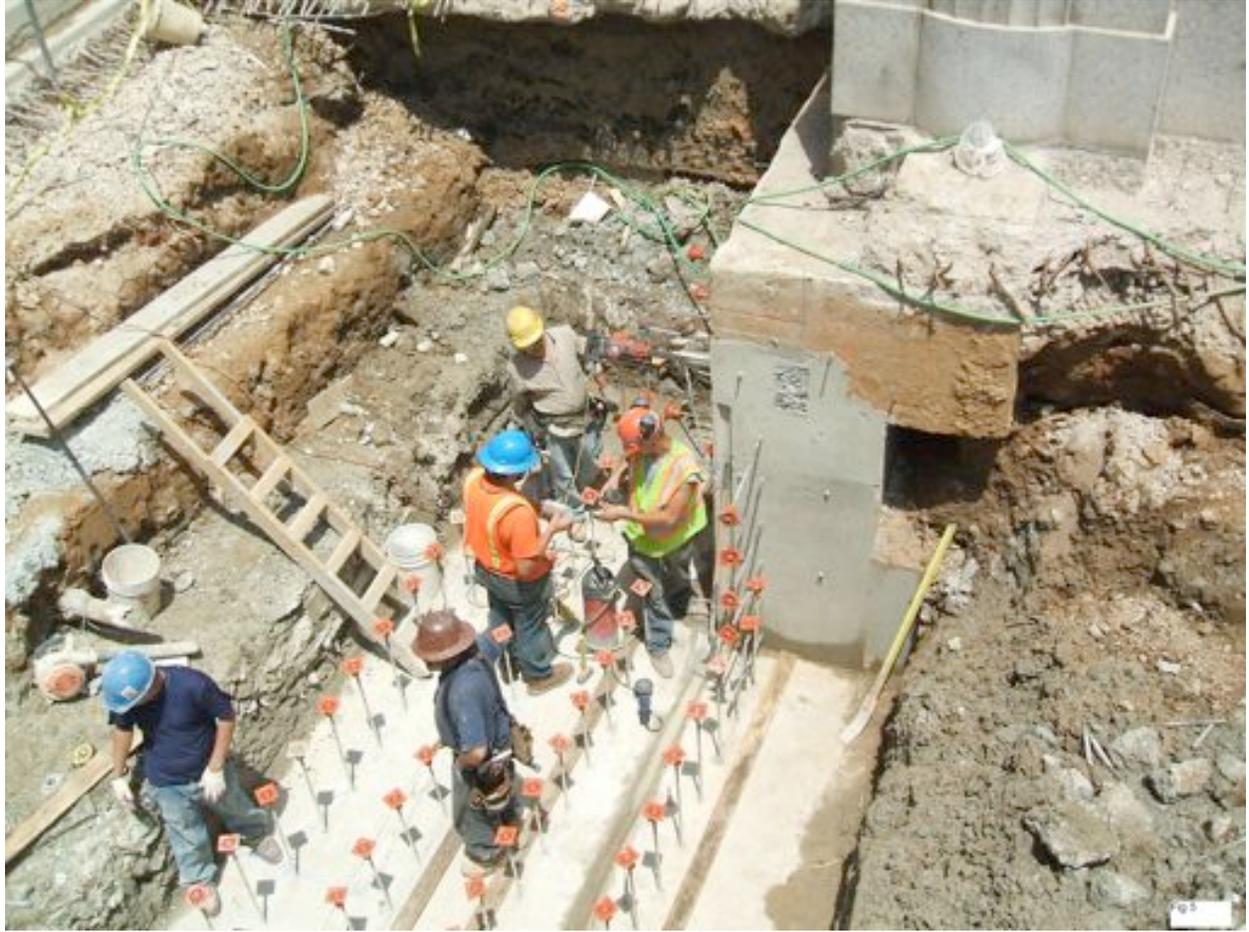
- An electrical duct bank was unearthed, and this required inspection and capping (Fig.4).
- Pipes and other conduit running through unearthed concrete bunkers were discovered in the excavation site. For obvious site safety concerns, this condition required inspection of the bunker prior to continuing the excavation. It was not known if live electrical conduits were present or if natural gas transmission lines were involved, but through inspection by the project engineer and NARA officials, and evaluation by GPR, it was determined that the lines were already capped.

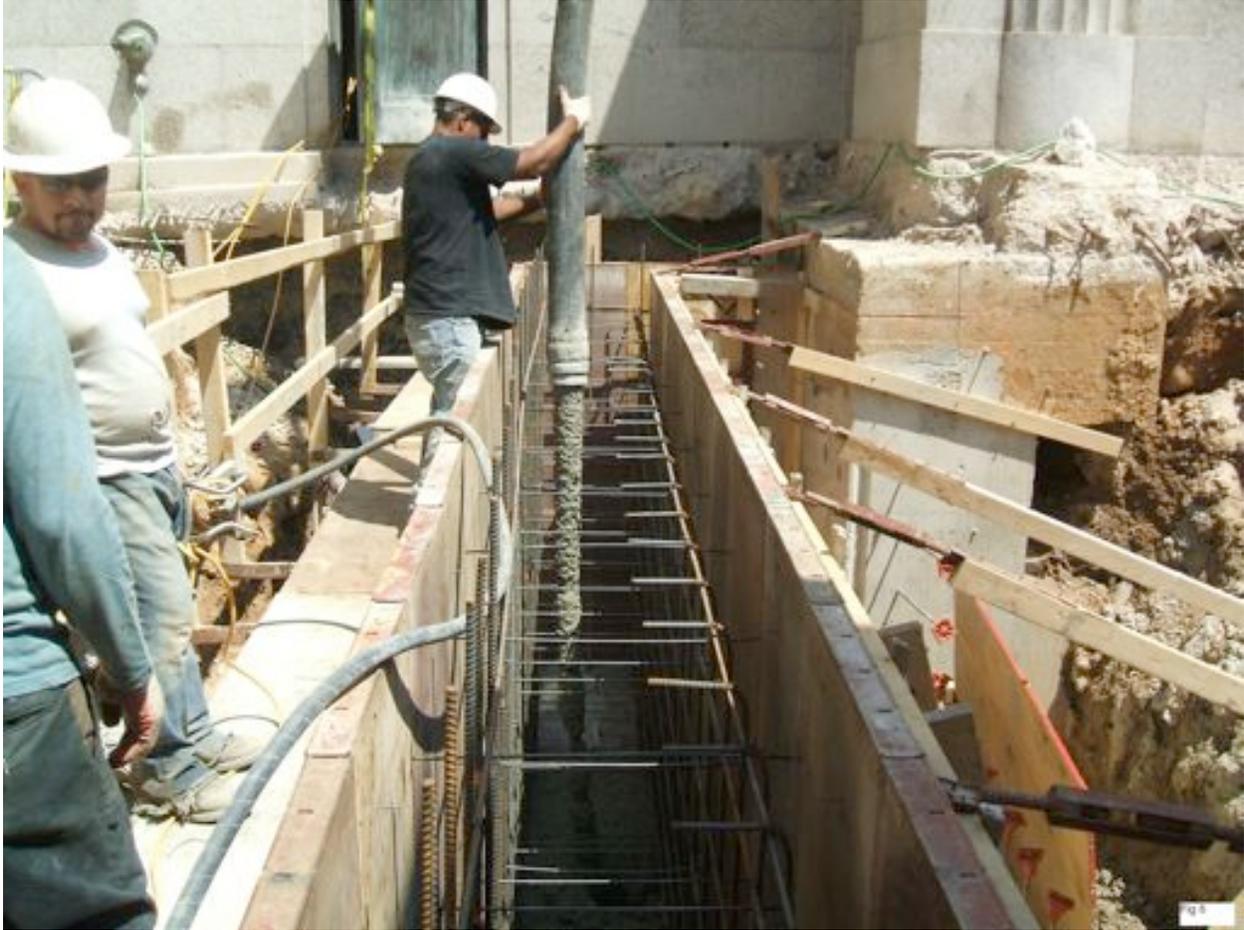
- Next, the pier cap supporting the very large Federalist style pilasters would need to be enlarged in order to properly install the flood barrier (Fig.5).Associated with this condition would be the need to design and install additional underpinning of the pilasters on each end of the barrier structure. This required an engineering redesign of the large pier cap beams at each end of the barrier so the barrier structure would be perfectly level and allow the flood gate to work properly. With the structural enhancements to the pier caps and underpinning completed, the construction of the footings and the watertight basin foundation walls proceeded (Fig.6).

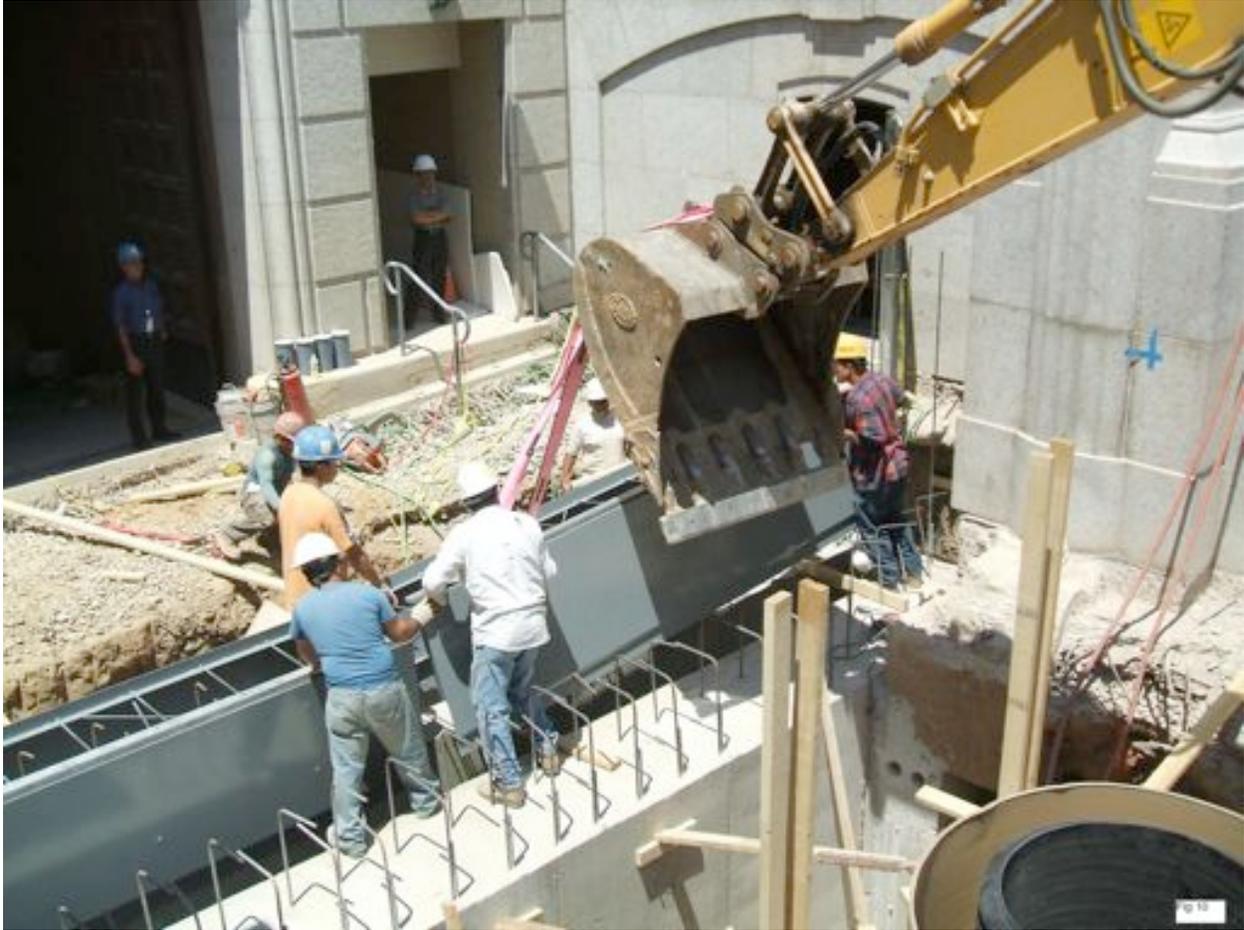
The lateral reinforced cap beams were formed atop the basin foundation walls to exacting dimensions (Fig.8), in order to receive the self-closing flood barrier hardware provided by PS Doors (Fig.9). With the use of a track excavator, the flood barrier concrete cap beam forms were placed atop the foundation walls (Fig. 10). Upon placement of the cap beam forms provided by PS Doors, which arrived from the manufacturer with installed steel reinforcing, it was discovered that some of the rebar atop the basin

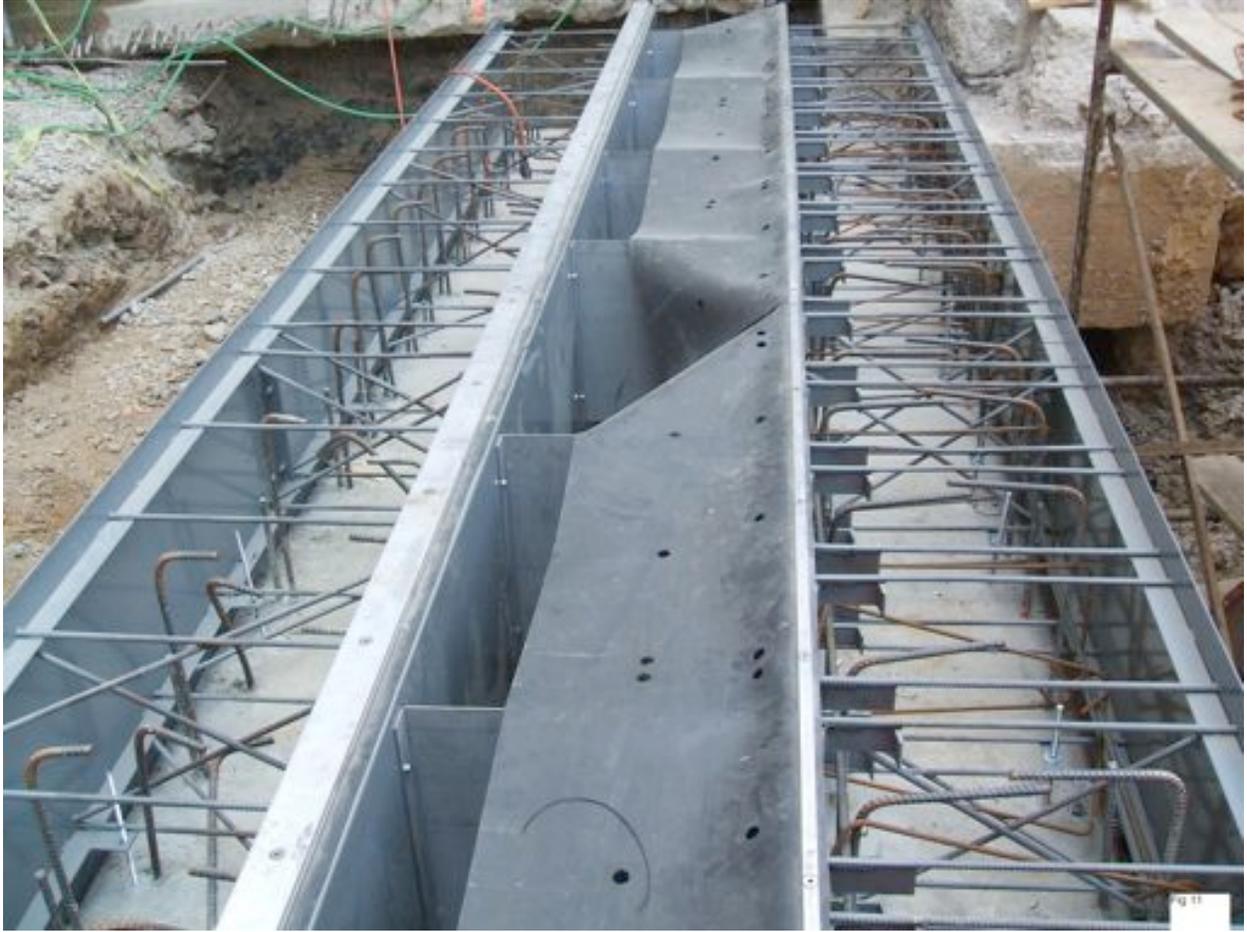
foundation wall required position alteration in order to receive the cap beam form (Fig. 11). Prior to placing concrete in the cap beam forms, the manufacturer's rep from PS Doors inspected the newly placed beam forms to verify the distance between the cap beams was to exact measurements in order to eventually receive the flood barrier gate hardware. Concrete was placed in the cap beams (Fig. 12), and following adequate curing time the flood barrier doors and associated hardware were installed. A flood test was successful and the self-closing flood barriers functioned as designed (Fig. 13).
