## White Oak Towers

### Plaza Deck Repairs & Waterproofing

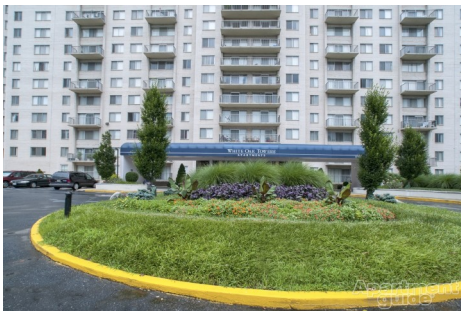
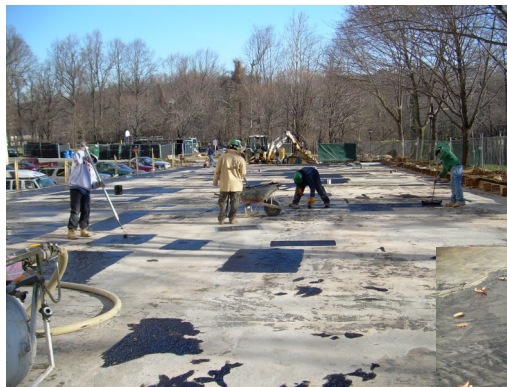
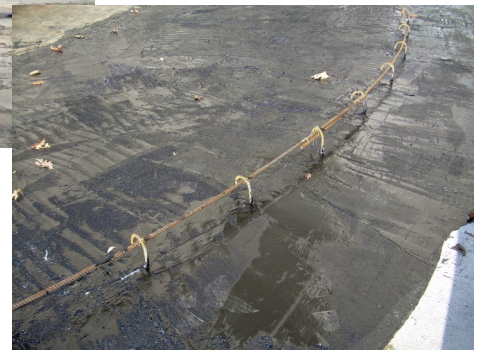
The purpose of this project was to replace the waterproofing over the garage and repair the concrete structure below the waterproofing. The garage is a reinforced concrete structure consisting of 2 levels. The top level is directly below the plaza, driveway entrance, and asphalt tennis court. The north part of the bottom level and the ramp between the levels are below an asphalt parking lot. The elevated structural surfaces are a cast in place slabs with joists spanning southwest to northeast, typically spaced at 3 feet on center. Joists have a depth of approximately 14" from the bottom of the structural slabs and their width range from 5 1/3" to 10 1/2". The garage is 30 plus years old.

- ◇ Removed and replaced all soil, concrete pads, sidewalk, and asphalt above garage
- ◇ Completely removed all existing waterproofing from top of the garage and applied new hot waterproofing
- ◇ Repaired the concrete structure below the waterproofing
- ◇ Partial and full depth repair of delaminated/spalled concrete slabs
- ◇ All corroded or exposed steel reinforcing bar was sandblasted clean and replaced as necessary
- ◇ Replacement of plaza finishes, tennis courts, asphalt and concrete driveways, and landscaping
