Concrete Protection & Restoration

Bayview Palms Condominium

Garage Repair

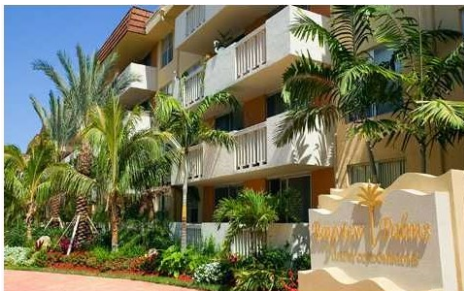
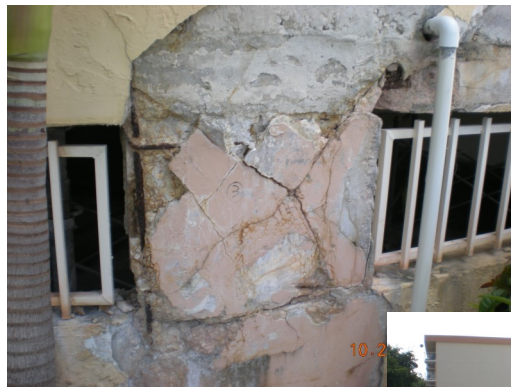
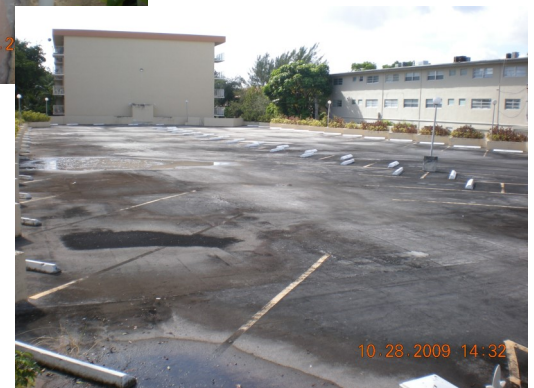
The two-story parking garage of the Bayview Palms Condominium had a substantial cracking problem with columns around the perimeter of the structure. The edge of the slab had spalls and deteriorated stucco, which allowed damage to the post-tension anchorages. Additionally, there were cracks thru the elevated slab and water infiltration, which leaked on the cars below from the planters and the parking deck.

- ◇ Demolish and eliminate some of the planters around the perimeter
- ◇ Repair the concrete areas that were spalled
- ◇ Repair damaged post-tensioned cables and provide cover over shallow cables
- ◇ Epoxy inject cracks through the slab
- ◇ Rout and seal minor cracks
- ◇ Install hot applied waterproofing and drainage to the remaining planters
- ◇ Install a traffic bearing deck coating system to provide long service life to the parking deck
